Diagnosis of abnormal temperature rise observed on a 275 kv oil-filled cable surface: a case study

Diagnosis of Abnormal Temperature Rise Observed on a 275 kV Oil-filled Cable Surface – A Case Study

This paper presents a case study on a 275 kV oil-filled cable. The condition assessment and diagnosis are based on analysis of cable surface temperature in relation to its current load and insulation dielectric loss. The work was initiated by a local abnormal temperature rise of 5.2 °C in cable surface temperature, which was observed during a routine inspection. The temperature rise occurred at bend area with a length of approximately one metre in the Blue Phase. No PD activity was identified using on-line PD measurement. The relation between cable surface temperature, cable core temperature and cable insulation condition was then simulated based on the thermal model of power cables. According to simulation analysis, poor condition of cable insulation or oil from an oil duct penetrating a region under the cable surface were identified as possible reasons for the problem observed. An in service X-ray scanning technique was employed for further investigation and to aid diagnosis. The X-

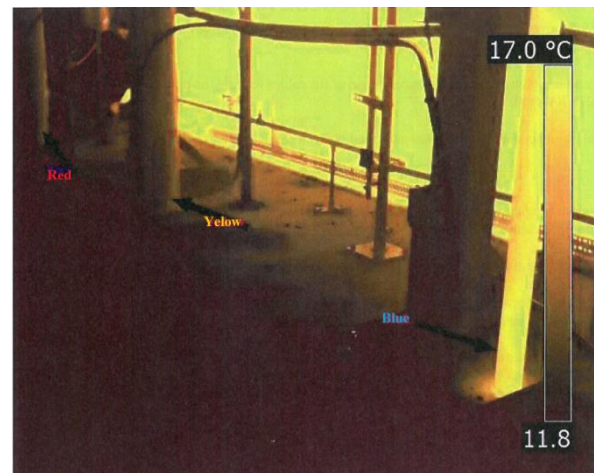
As shown in Figure 3, the Blue phase is apparently bent between two cleats which are used to fix the cable. In Nov. 2017, an inspection via infrared thermal images of the three phase cable, at 6 °C ambient temperature, revealed a local cable surface temperature rise of 5.2 °C above other phases around the bent area of Blue phase (in Figure 4). In details, the temperature of Blue phase was 17 °C which was 11 °C rise above the ambient temperature, while the temperature of the other phases were 11.8 °C which were 5.8 °C higher than the ambient temperature.

Figure 4. Infrared thermal image of the Blue Phase.

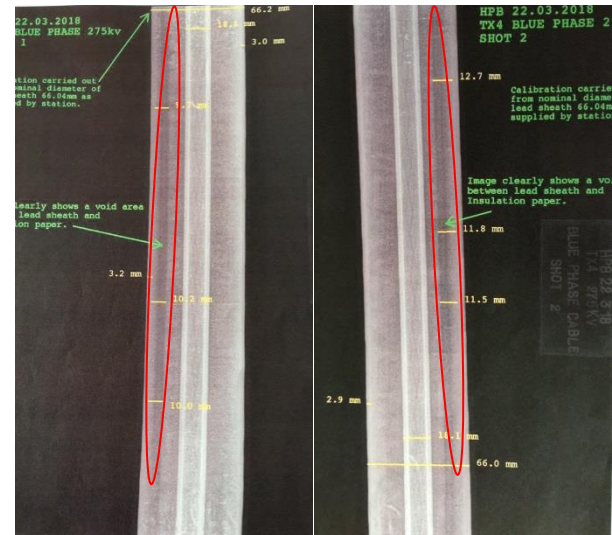
An X-ray technique was used to help researchers confirm the proposed fault diagnoses. The X-ray images were taken from both front and back side of the Blue Phase, as shown in Figure 12a and Figure 12b, respectively. Cable

construction is clearly displayed in the two X-ray images. Slight distortion of the cable can be demonstrated from inconsistent outer diameters of lead sheath, which are 66.2 and 66.0 mm respectively, and various thickness of the lead sheath which are 2.9, 3.2 and 3.0 mm respectively. The red ellipses in Figure 12a and Figure 12b show the oil region between the cable insulation and lead sheath, this has different widths at various positions.

(a) Front images (b) Rear images
– the red ellipse shows the area of oil leakage

Figure 12. X-ray images of Blue Phase cable acquired on March 22nd 2018.

The images show that the thickness of the lead sheath varies, i.e. 3.2, 3.0 and 2.9 mm. The diameter of the conductor is shown to be 18.1 mm and the outer diameter of the lead sheath is shown to vary between 66.2 and 66.0 mm. The X-ray images also indicate a narrow region between cable insulation and lead sheath filled with oil. The lengths of the void at various positions in Figure 12a are measured as 9.7, 10.0 and 10.2 mm and in Figure 12b as 12.7, 11.8 and 11.5 mm. As shown in Figure 12c, an oil filled region between the cable insulation and lead sheath, approximately one meter in length, may have been responsible for the abnormal temperature rise. As shown in Figure 13, channels formed due to distortion and deformation allow the higher
